# Falla en transformador seco

EXTRUSION, TRANSFORMADOR TR-16, FASE TAPE ROJO

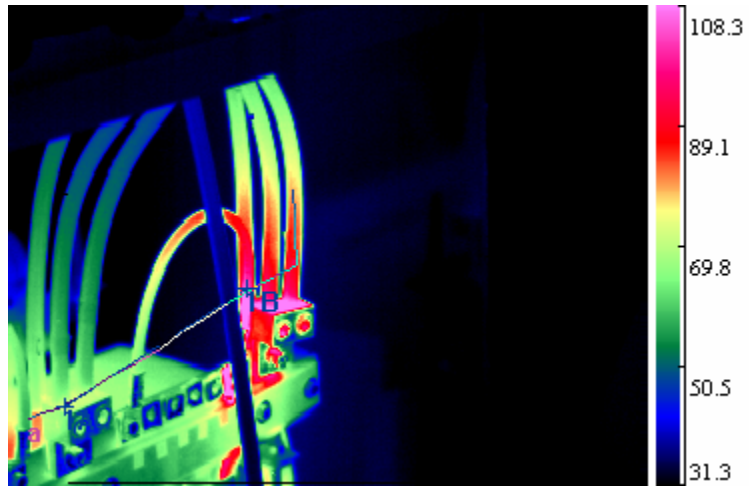
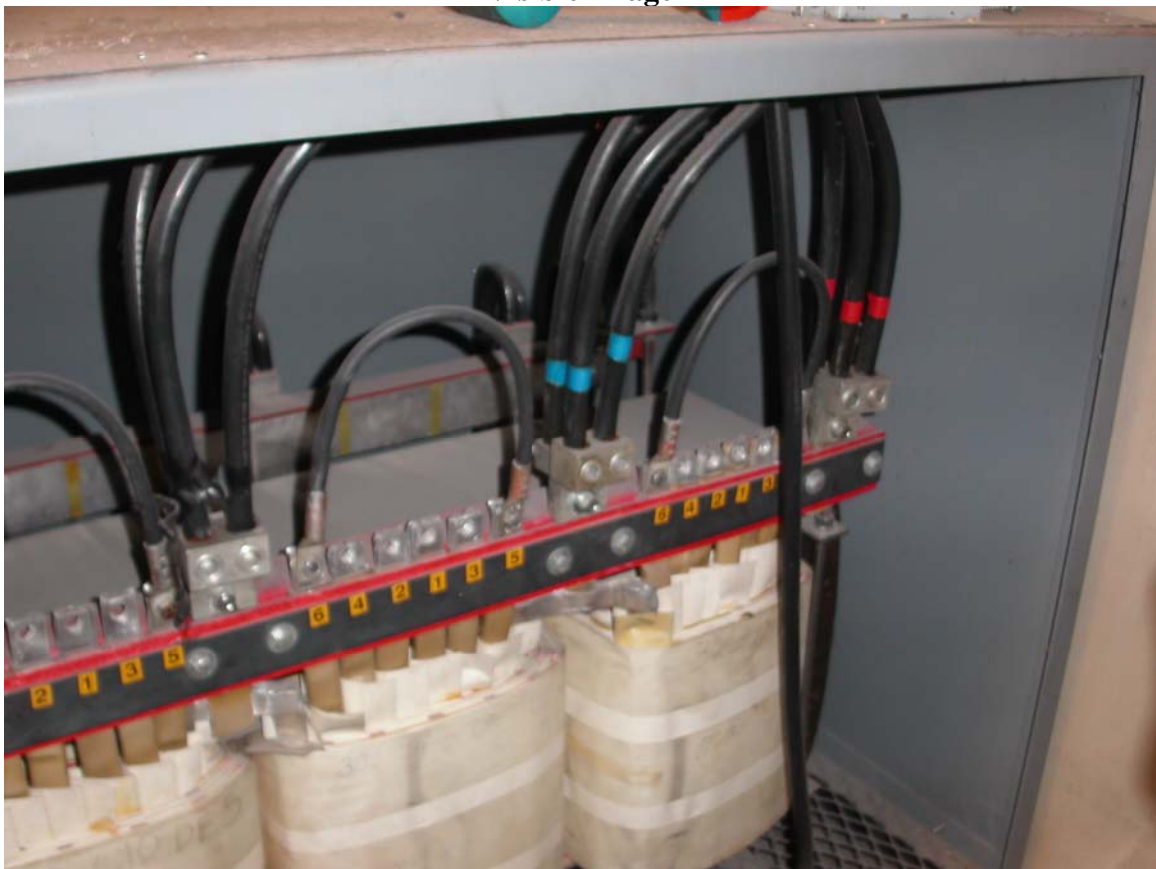
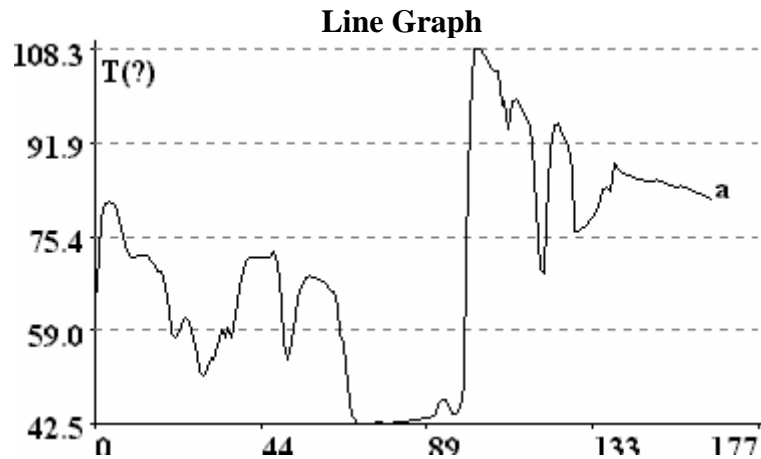
Name:IMAGE018.IMG

Num	P-A	P-B	Delta	Ratio(%)
1	69.2	108.3	39.1	54.3

HOT SPOT EN CONEXION . LIMPIAR Y REAPRETAR

PRIORIDAD IMPORTANTE

DESARMAR, LIMPIAR Y REAPRETAR CONEXION.
