## EJEMPLO DE TOMAS CON TELEFOTO

<b>Termografía</b>		<b>Inspected Location: CR Bard Nogales Sonora</b>			
<b>Inspected By: Fernando Castillo</b>		Termógrafo Nivel II por ASNT			
<b>File Name</b>	Reporte 3	<b>Created Date</b>	2019/07/30	<b>Created Time</b>	03:20:33
<b>Emissivity</b>	0,95	<b>Humidity</b>	70%	<b>Distance</b>	10,0mm
<b>Ambient</b>	34,6°C	<b>Max Temp</b>	61,4°C	<b>Min Temp</b>	3,5°C
<b>IR Image</b>

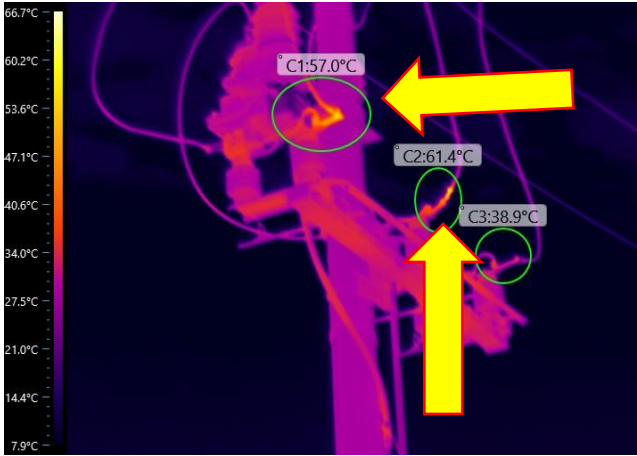
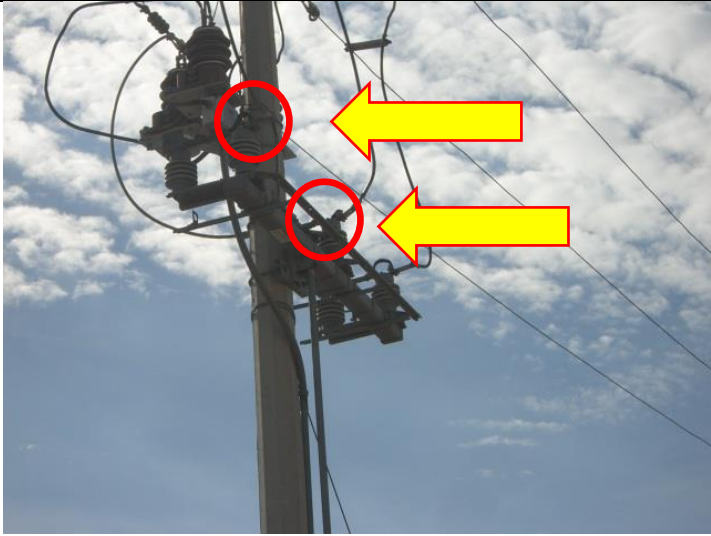
<b>C1TMax</b>	<b>57.0°C</b>
				C1TMin	10.8°C
<b>Visible Image</b>

C1TMediad	31.6°C
				<b>C2TMax</b>	<b>61.4°C</b>
				C2TMin	6.5°C
				C2TMediad	16.3°C
				<b>C3TMax</b>	<b>38.9°C</b>
				C3TMin	6.3°C
				C3TMediad	14.2°C

4.wav	
<b>Component</b>	Poste acometida principal Sección de transformadores.				
<b>Detail</b>	<b>Dos conexiones sobrecalentadas. C1 y C2</b>				
<b>Analysis &amp; Recommended Action: Desarmar, limpiar y reapretar</b>

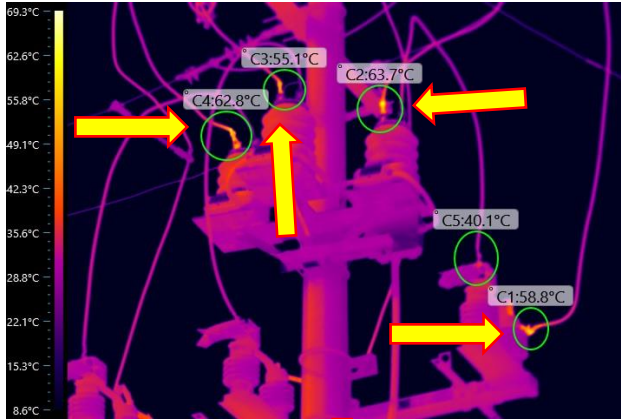
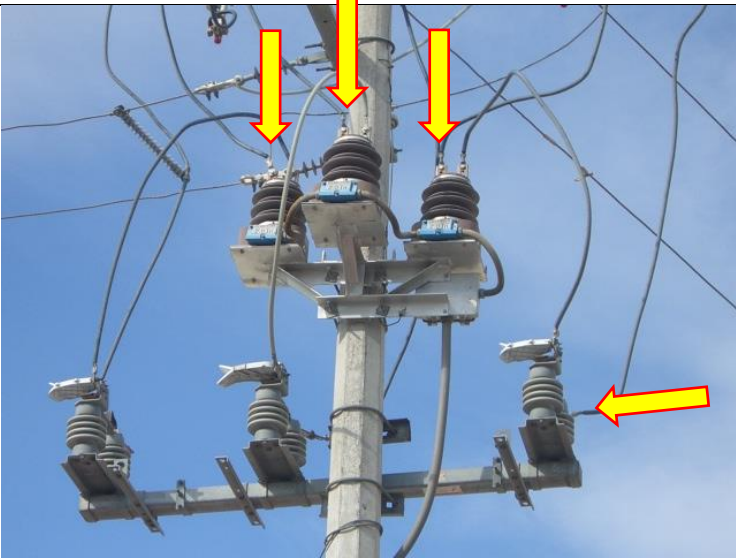
<b>Termografía</b>		<b>Inspected Location: CR Bard Nogales Sonora</b>			
<b>Inspected By: Fernando Castillo</b>		Termógrafo Nivel II por ASNT			
<b>File Name</b>	Reporte 3	<b>Created Date</b>	2019/07/30	<b>Created Time</b>	03:22:25
<b>Emissivity</b>	0,95	<b>Humidity</b>	70%	<b>Distance</b>	10,0mm
<b>Ambient</b>	34,6°C	<b>Max Temp</b>	63,7°C	<b>Min Temp</b>	0,4°C
<b>IR Image</b>

C1TMax	58.8°C
				C1TMin	3.9°C
<b>Visible Image</b>

C1TMediad	18.4°C
				<b>C2TMax</b>	<b>63.7°C</b>
				C2TMin	2.9°C
				C2TMediad	27.0°C
				<b>C3TMax</b>	<b>55.1°C</b>
				C3TMin	4.4°C
				C3TMediad	18.9°C
				<b>C4TMax</b>	<b>62.8°C</b>
				C4TMin	2.6°C
				C4TMediad	15.5°C
				<b>C5TMax</b>	<b>40.1°C</b>
				C5TMin	2.8°C
				C5TMediad	17.5°C
<b>Component</b>	Poste acometida principal Sección de transformadores.				
<b>Detail</b>	<b>Dos conexiones sobrecalentadas. C1, C2, C3 Y C4</b>				
<b>Analysis &amp; Recommended Action: Desarmar, limpiar y reapretar</b>
