Infratherm Termografia			Inspected Location:		
Inspected By: Fernando Castillo			Termógrafo Nivel II por ASNT		
File Name	IRI_20190515_010854.jpg	Created Date	2019/05/15	Created Time	08:08:54
Emissivity	0.95	Humidity	70%	Distance	3.0mm
Ambient	28.5°C	Max Temp	159.9°C	Min Temp	150° C
IR Image

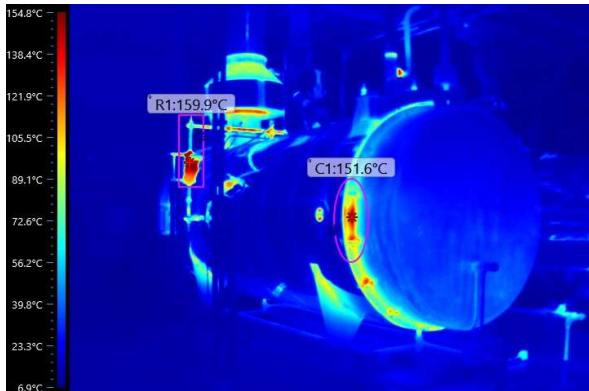
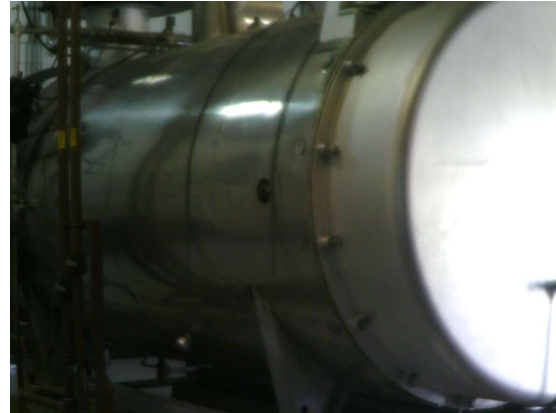
C1MaxT	151.6°C
				C1MinT	--°C
Visible Image

C1AvgT	--°C
				C1Emissivity	0.95
				C1Distance	3.0m
				C1Humidity	70%
				R1MaxT	159.9°C
				R1MinT	--°C
				R1AvgT	--°C
				R1Emissivity	0.95
				R1Distance	3.0m
				R1Humidity	70%
Component Detail

0.wav	
Analysis & Recommended Action:
